Myer Ezrin

Plastics Failure Guide

Cause and Prevention

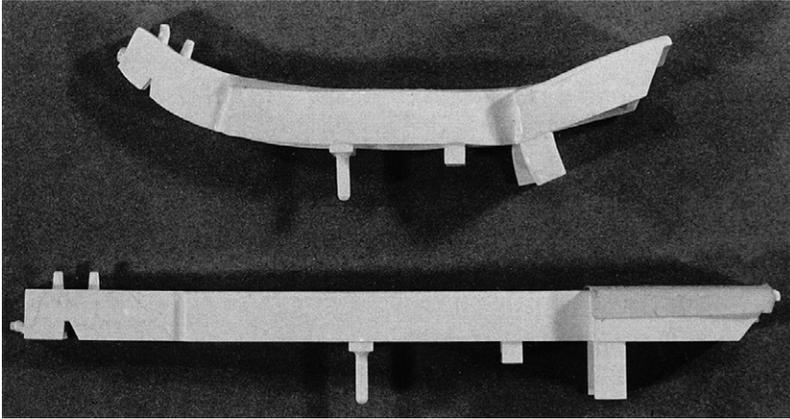
In fracture, stress is additive: internal stress of molding, external mechanical stress of a spring, and the environmental stress condition. All together, the parts could not resist the total stress. The solvent stress-cracking agent may be thought of as "the straw that broke the camel's back." The high frozen-in stress is indicated in

Figure 2.38 [4] by the shrinkage and distortion of a piano key on heating above the glass transition temperature ( $T_g$ ), compared with an unheated key. Fracture occurred at a protruding hook at the gate end from the tension of an attached spring. The frozen-in stress was particularly high at that point, as indicated by heat shrinkage (Fig. 2.39). Redesign and molding to reduce orientation improved the product. Cracking of PE paint cans was also attributed to frozen-in stress (Fig. 7.9).

**FIGURE 2.38** Piano key before and after heating to release frozen-in stress ([4], Fig. 2, reproduced with permission)

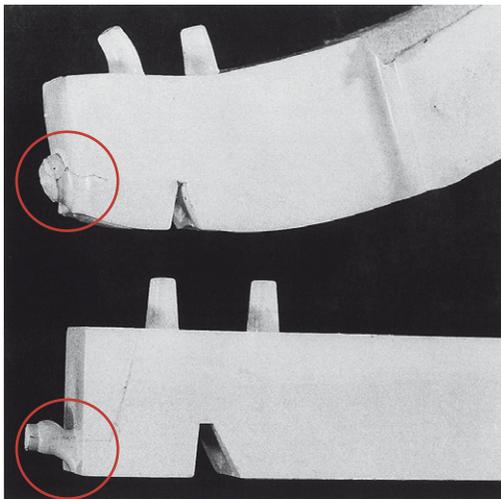
**FIGURE 2.39** Closeup of hook end (left) on SAN piano key before (bottom), and after heat shrinkage (top) ([4], reproduced with permission)

Section 2.6.3 in Chapter 2 reports the case of SAN (styrene acrylonitrile) injection molded piano keys that failed due to environmental stress-cracking when MEK (methyl ethyl ketone) solvent was used to clean the back of the piano. MEK condensed on the piano keys, causing stress-cracking. Section 2.6.3 assigns responsibility for the failure mainly to processing, which gave a high level of frozen-in stress, particularly at the hook end (Fig. 2.39) where failure occurred. Note the very high shrinkage at the hook end after heating the part to relieve frozen-in stress.

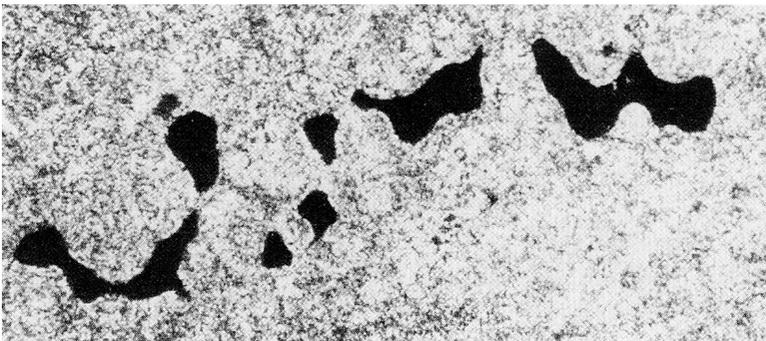
Flow and orientation were described as “pathways to part perfection” with ABS [17]. Failures have been reported due to failure to apply sufficient time and pressure to freeze the gates, leading to shrinkage voids (Fig. 5.6) [18]. The effect of mold temperature on orientation and on the weld line is shown by tensile specimens molded at three temperatures [19]. At the lowest temperature, orientation and frozen-in stress are the highest, as readily seen by shrinkage after heating (Fig. 5.7) [19]. The relationship between melt flow and shrinkage, warpage, and structural performance is important for strong and stable mechanical properties [20]. Frozen-in stress and related features of injection molding are treated with respect to the distribution of physical properties in molded parts [21].

**FIGURE 5.6** Shrinkage voids created by insufficient time and pressure to freeze the gates during injection molding process ([18], Fig. 15.4, courtesy of Engineering Design, published by E. I. Du Pont de Nemours and Co., Inc.)

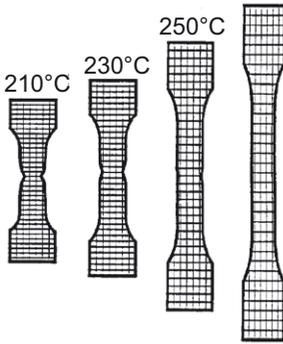
**FIGURE 5.7** Thermally shrunken double-gated standard tensile bars of polystyrene molded at melt temperatures: 210, 230, and 250 °C (from left to right); mold temperature, 40 °C. As molded bar, not thermally shrunken, far right (Section 1.14 [29], (Fig. 6) and [19], reproduced with permission)

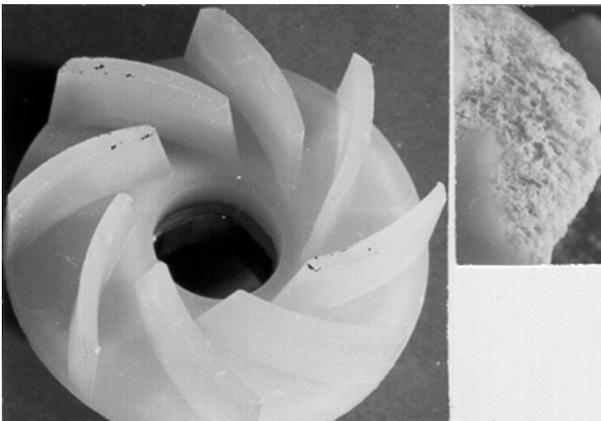
An example is given of oxidative degradation of a polymer, which is very readily degraded in processing and service if there is inadequate antioxidant, by small PP rotors used in hot water service (Section 1.14 [32]). Pellets, as-molded rotors, and degraded rotors were available to track OIT values from “cradle to grave.” See Table 4.1 and Section 5.8.3 (Test Methods) regarding OIT. Rotors in service for about a year experienced substantial degradation under service conditions of hot water, steam, and air. Figure 5.9 (Section 1.14 [32] Fig. 2) shows a complete unused rotor, which measures 2 inches in diameter. The photo includes a close-up of the degraded end of a fin of a used rotor. Figure 5.10 (Section 1.14 [32] Fig. 3) is the DSC-OIT thermogram of pellets, unused rotor as molded, and a rotor degraded in service.

**FIGURE 5.9** Unused PP rotor and close-up of a degraded fin of a used rotor (Section 1.14 [32], Fig. 2, reproduced with permission)

The pellets were well stabilized (OIT > 50 min.), so that an OIT value of 4 minutes for molded rotor indicates that most of the antioxidant was consumed in processing. The type of service (hot water, air) readily consumed the remaining antioxidant, leaving the rotors very susceptible to degradation in service. It is possible another antioxidant system might have provided better protection in processing and service.

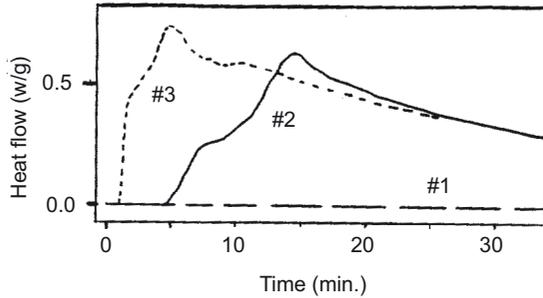
**FIGURE 5.10** DSC-OI time at 200 °C of #1 unmolded PP pellets (> 50 min.); #2 unused molded rotor (4 min.); #3 rotor degraded in service (1 min.) (Sec. 1.14 [32], Fig. 3, reproduced with permission)

Isothermal DSC temperature was 200 °C. The OI time for pellets was > 50 minutes; for as-molded rotors, time was 4 minutes; and degraded rotor was 1 minute. Time to purge the DSC cell with oxygen following equilibration in nitrogen was about 1 minute, so that the OI time of degraded rotor was practically zero.

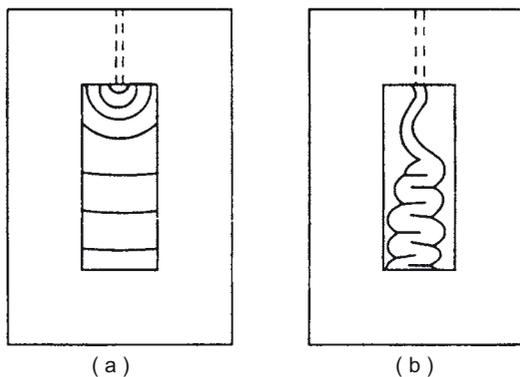
Jetting [25] is a problem peculiar to injection molding (Fig. 5.11[b]). It is associated with the swelling melt emerging from the gate and not striking the walls as it enters the mold. Thus, jetting is accentuated by melts exhibiting low extrudate swell, and by gate design that causes emerging melts not to strike the mold walls. Molded parts formed by jetting are not desirable from the point of view of both appearance and strength.

**FIGURE 5.11** Diagram of (a) simple mold filling and (b) jetting ([25] p. 2328, reproduced with permission)

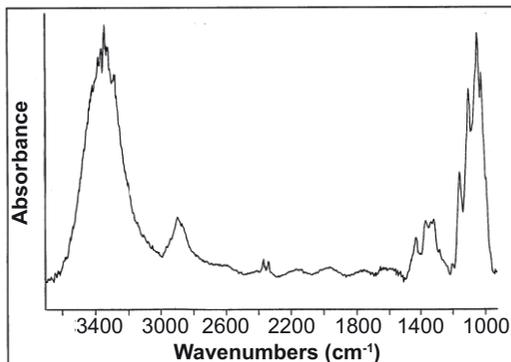
**FIGURE 14.17** Micro IR spectrum of contaminant in Fig. 14.16 ([8], Fig. 4, courtesy of the Society of Plastics Engineers, Newtown, CT, [www.4spe.org](http://www.4spe.org))
