Myer Ezrin

Plastics Failure Guide

Cause and Prevention

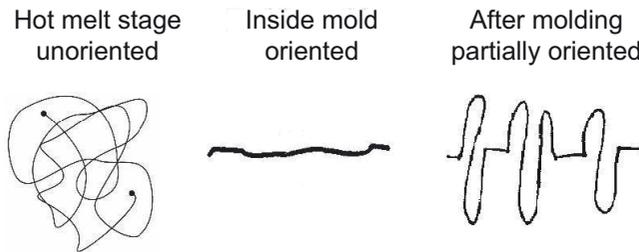
**FIGURE 5.8** A conceptual portrayal of polymer molecular orientation at various stages of injection molding (Section 1.14 [29], (Fig. 5) and [19], reproduced with permission)

molecules (Fig. 5.8). The high directional force associated with molding enhances the alignment of molecules. On cooling in the mold, some orientation is retained, which can cause problems associated with internal stress, such as environmental stress-cracking. In the figure, partial orientation after molding is not intended as an accurate depiction of that state. The purpose is to suggest a partially oriented configuration, not necessarily as depicted.
